Evaluation of Metal Containers for Shipping Hazardous Materials

(U.S.) Naval Air Development Center, Warminster, PA

Department of Transportation, Wishington, D. Office of Hazardous Materials

Sep 72

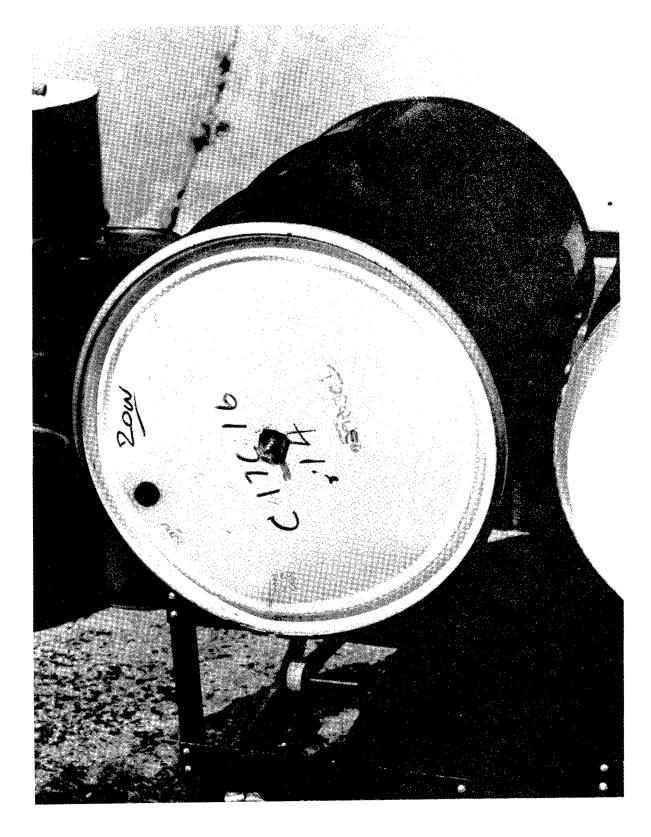
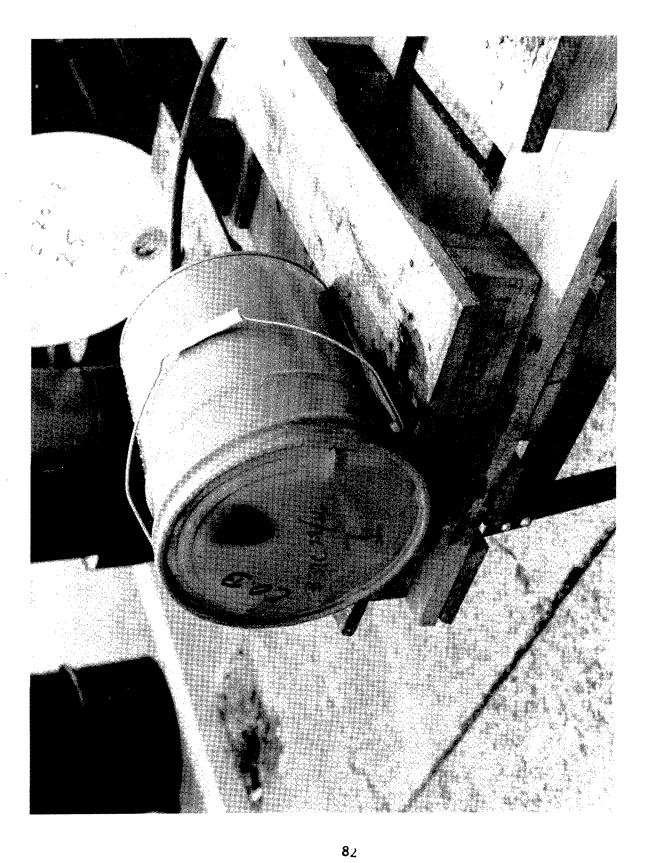
The pail fa lures were noted as a leak at the flex spout for Exhibit 29, a leak at the upper chime for Exhibit 36, and a leak at the cover for Exhibits 7, 48, and 73. The failures are illustrated in Figure 4 through Figure 11.

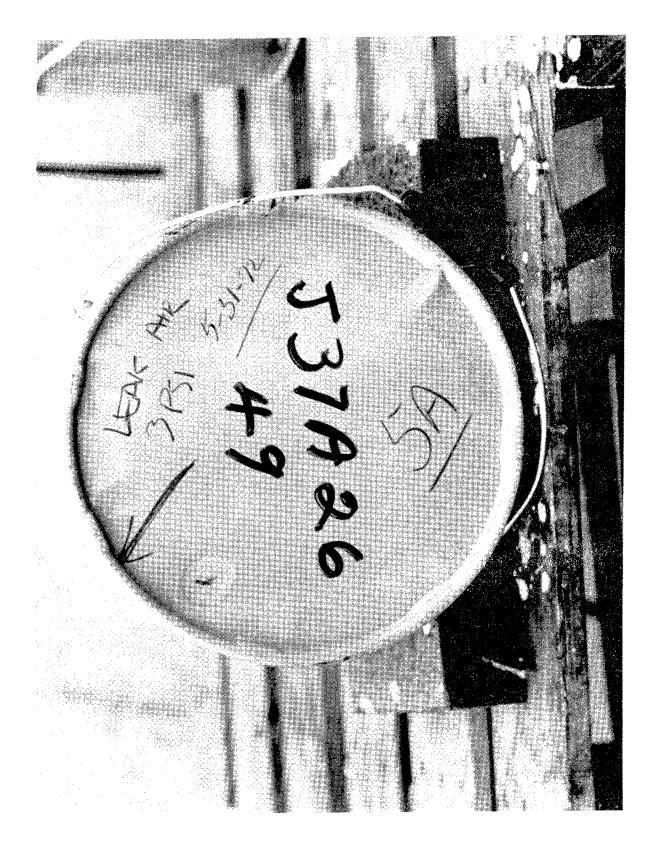
The prescured were maintained for 5 minutes or unless a leak was noted by a drop in the pressure gauge. After reaching the required pressure, a bubble supporting solution was applied to the seams, upper and lower chimes, and fittings. The containers were examined for evidence of leakage. The results reported in Table 4 reveal that no drums failed the test; becover, five pails failed the test. The failure and noted as leaks at the lids for Exhibits 9, 10, 49, and 76. Exhibit 55 leaked at the intersection of the side seam and top chime. The type of failures are illustrated in Figures 12 and 13.

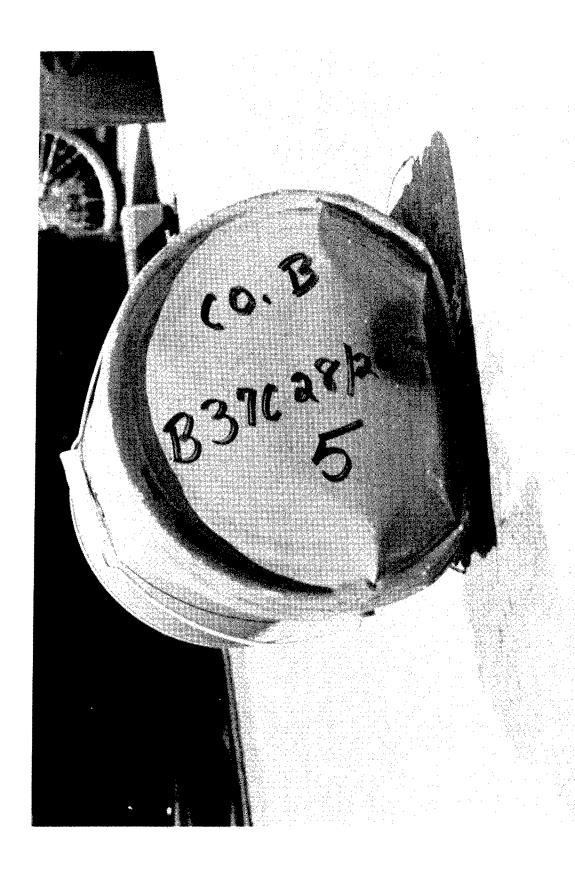
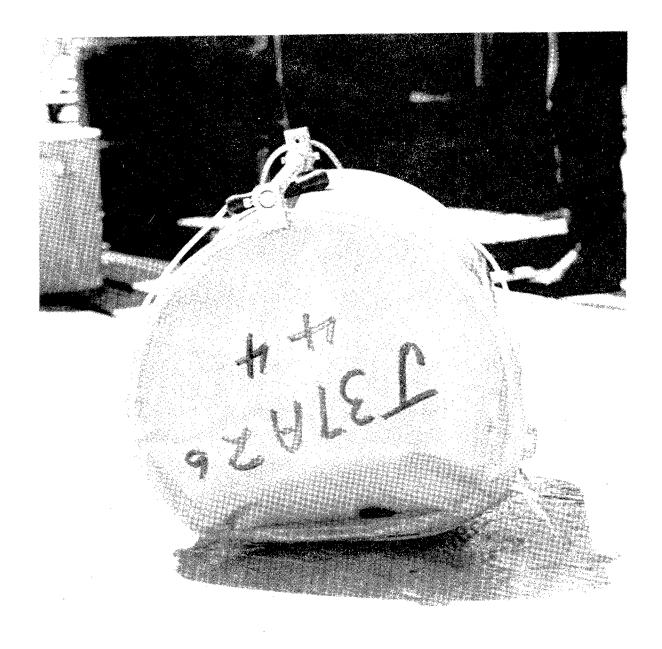
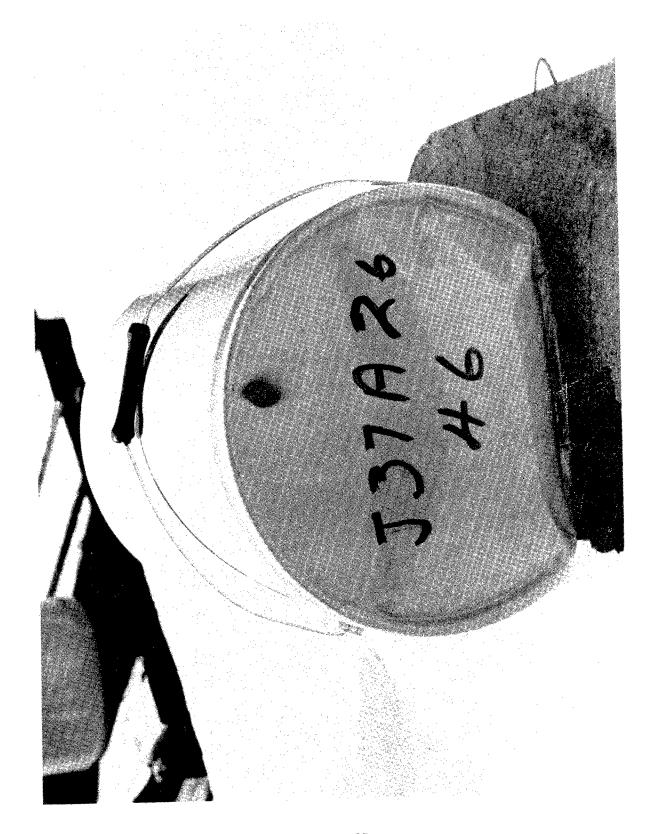
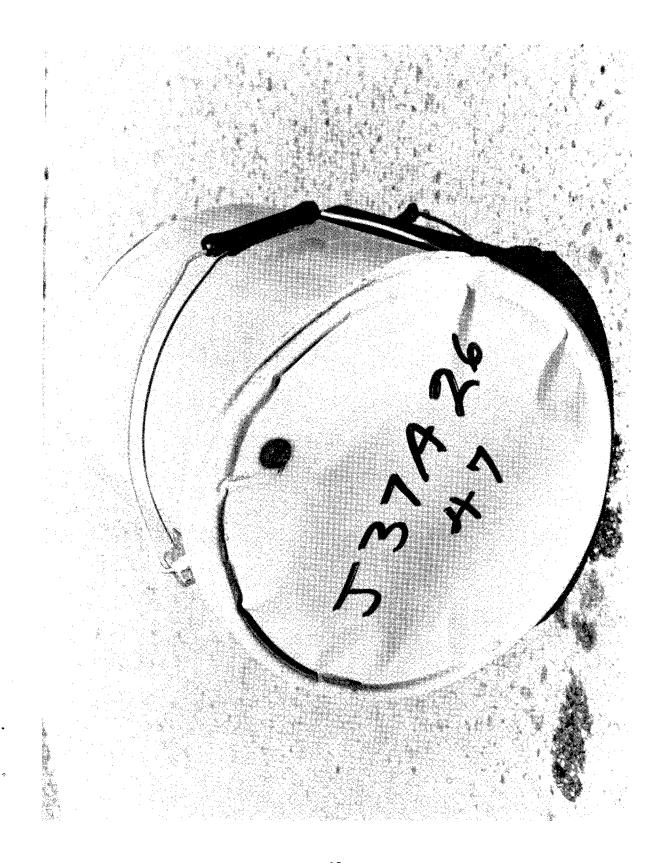
FIGURE 24

possessible. The drum failures were noted as leaks in the somet area. Inhibits 10, 16, 50, 54, 68, 141, and leaks at the looking ring joint for Exhibits 132 and 140. The latter drums (132 and 140) were not tested, the leaks having occurred when they were lifted for testing. The failures are illustrated in Figures 15 through 19. Pail failures were noted as a leak at the flex spout of Exhibit 37, severe leaks in the impact area for Exhibits 5, 6, 8, and 57 when dropped from 32 inches, and a slight leak for Exhibit 67 when dropped from 28 inches. Exhibits 41 and 44 leaked after a 4-foot drop, Exhibit 43 leaked after a 42-incl down, and Exhibits 46 and 47 leaked after a 36-inch drop. Typical failures are illustrated in Figures 20 through 26.

DIAGONAL DROP TEST

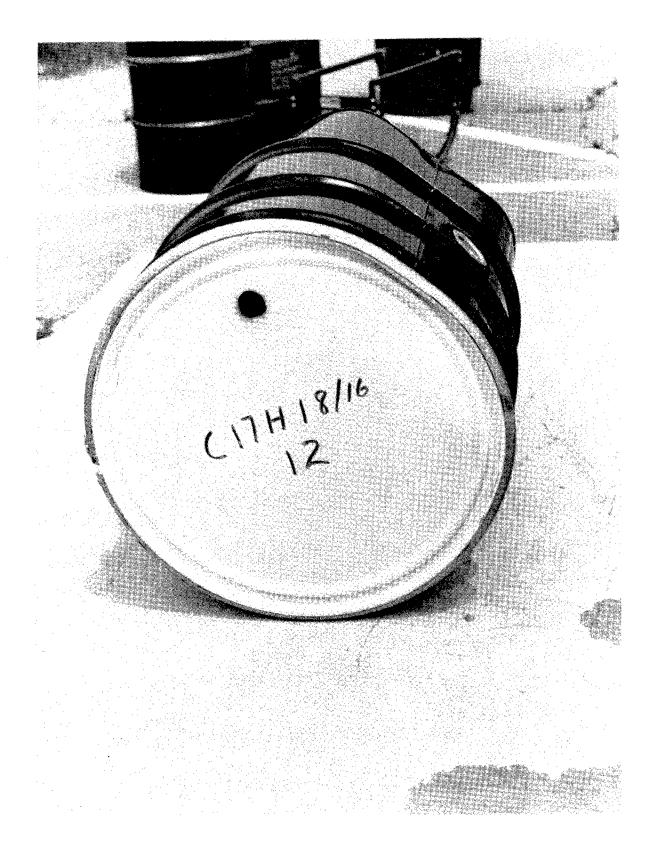
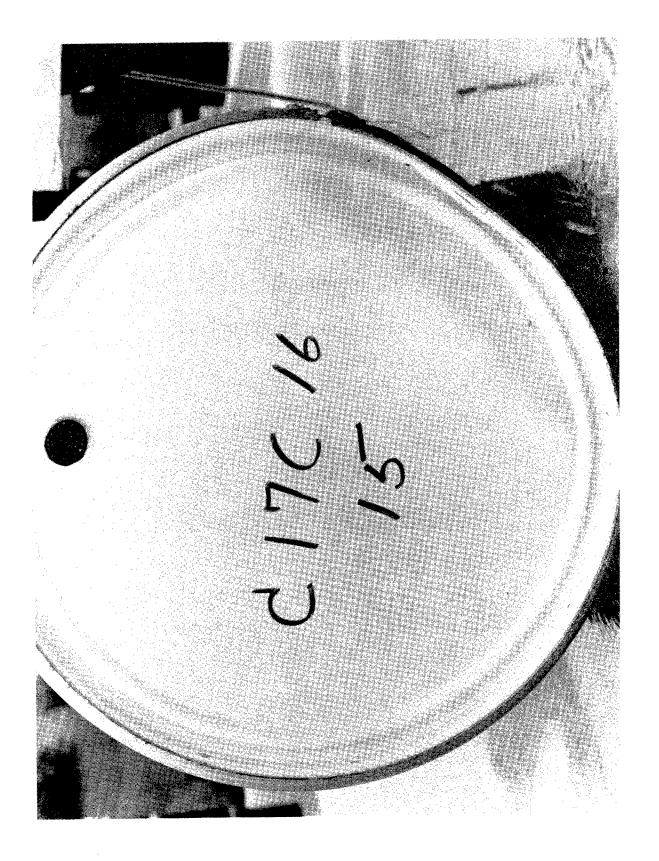
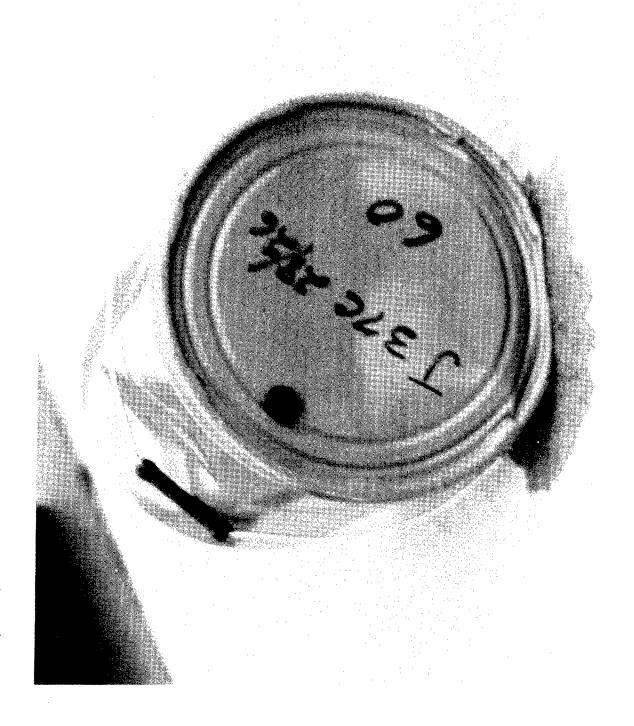
FIGURE 28

Horizontal Drop Test. The containers were prepared and tested in the same manner using the same height and test equipment as for the inequal drop test, with the exception that the containers were raised as illustrated in Figure 27 and dropped so that the side seam impacted the beat and After drop, the container and pad were examined for spillage. It results reported in Table 4 reveal that seven drums and six pails failed the test. Failures for the drums were noted as leaks at the locking ring joint of Exhibits 12, 15, and 73, and Exhibit 39 leaked at the end of the crush pattern. Exhibit 110 leaked at bottom chime, and Exhibits 140 and 143 leaked at the locking ring joint when lifted by the crame to be dropped. The latter two drums (142 and 143) were not dropped. Failures of the pails were noted as leaks at the covers of Exhibits 11, 45, 50, 60, 61, and 66.

Typical failures are illustrated in Figures 28 through 35.

HORIZONTAL DROP TEST

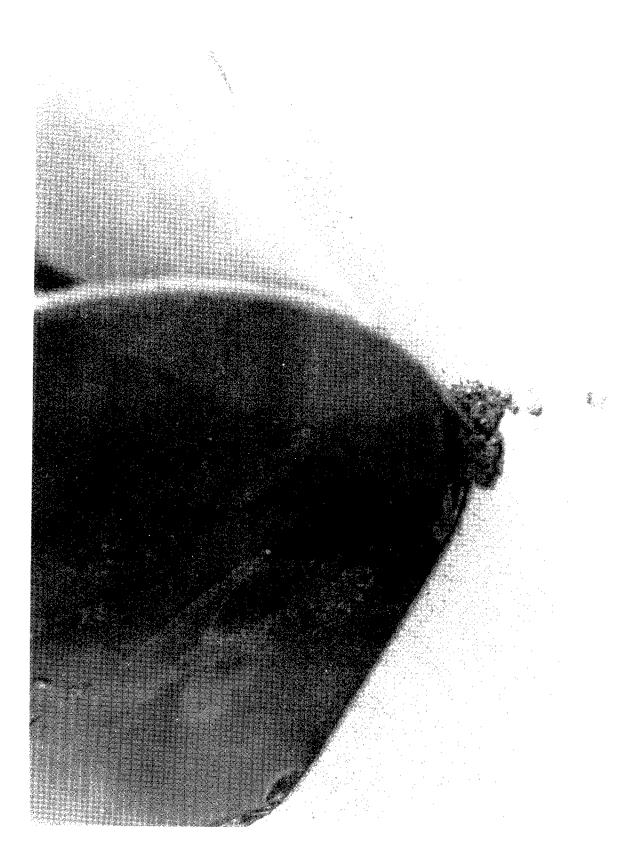
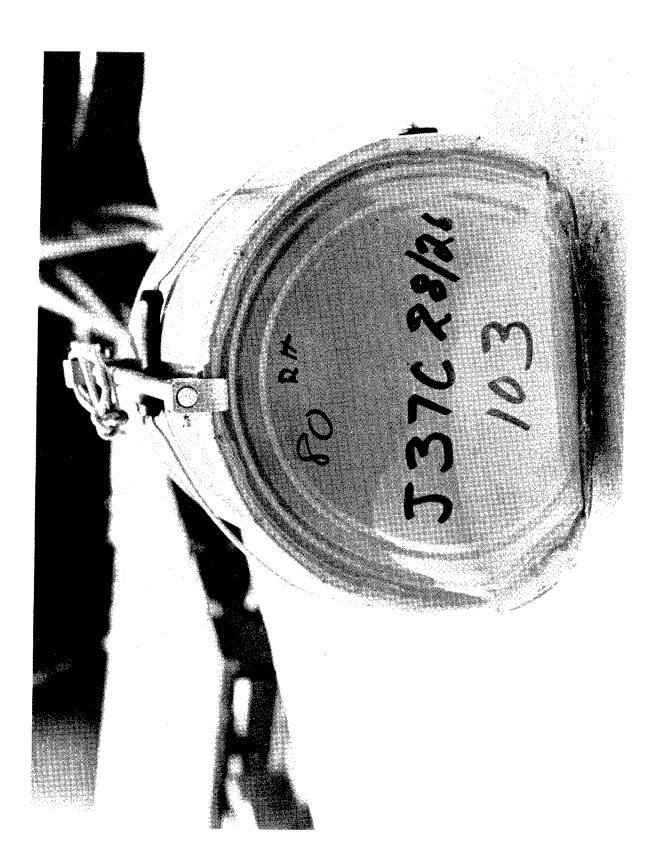
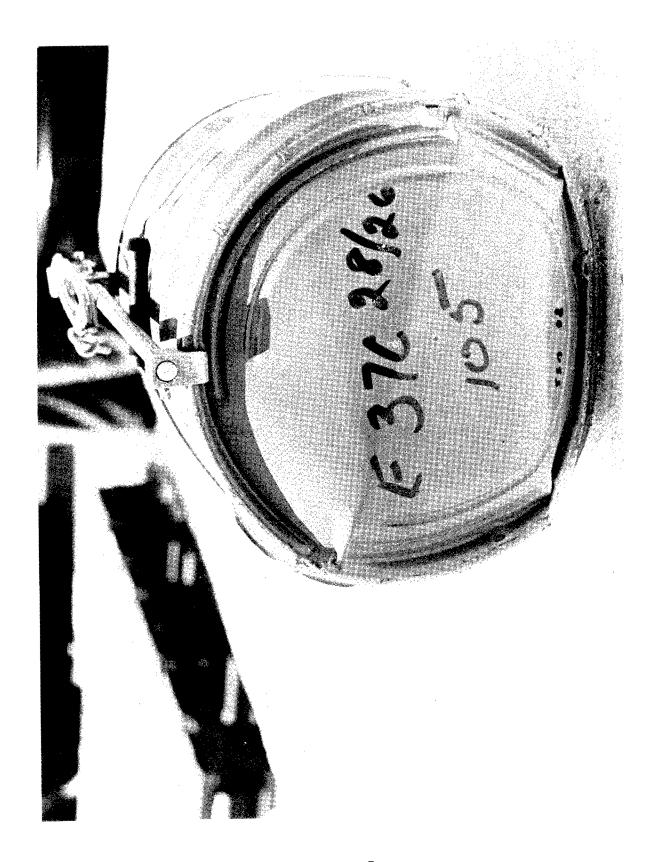
The results reported in Table 4 indicate that seven drums and five pails failed. Drum failures were noted as a split chime at the bottom of the container for Exhibit 71, a leak at the end of the crush pattern for Exhibit 158, and a leak at the ring closure for Exhibits 69, 160, and 163. Metal tore 3 inches at the bottom chime for Exhibit 157 and a leak at the ring closure for Exhibit 69. Failures for the 5 gallon pails were noted as leaks at the end of the crush patterns for Exhibits 90, 91, 103, 105, and 116. The failures are illustrated in Figures 36 through 46.
